Re: PROTECO Superfund Site in Peñuelas, Puerto Rico

AIDA T. FUENTES RIVERA
EQB LAND POLLUTION CONTROL AREA
HAZARDOUS WASTE DIVISION
OCTOBER 1990

The present project is intended to identify the Solid Waste Management Units (SWMUs) and Areas of Concern (AOC) that could have potential or a history of hazardous wastes releases at the Digital Equipment Corporation (DEC) of San Germán, Puerto Rico (PRD991291857). SWMUs or areas for which no further action would be recommended will not be included in this report. The 12.89-acre DEC site in San Germán is an active computer circuit board manufacturing facility. It is located at the state road PR-362, Km. 1.0 Barrio Guzmán, San Germán towards the Southwest side of the Island (latitude 18° 05' 28"N; longitude 67° 02' 18"W). Its postal address is:

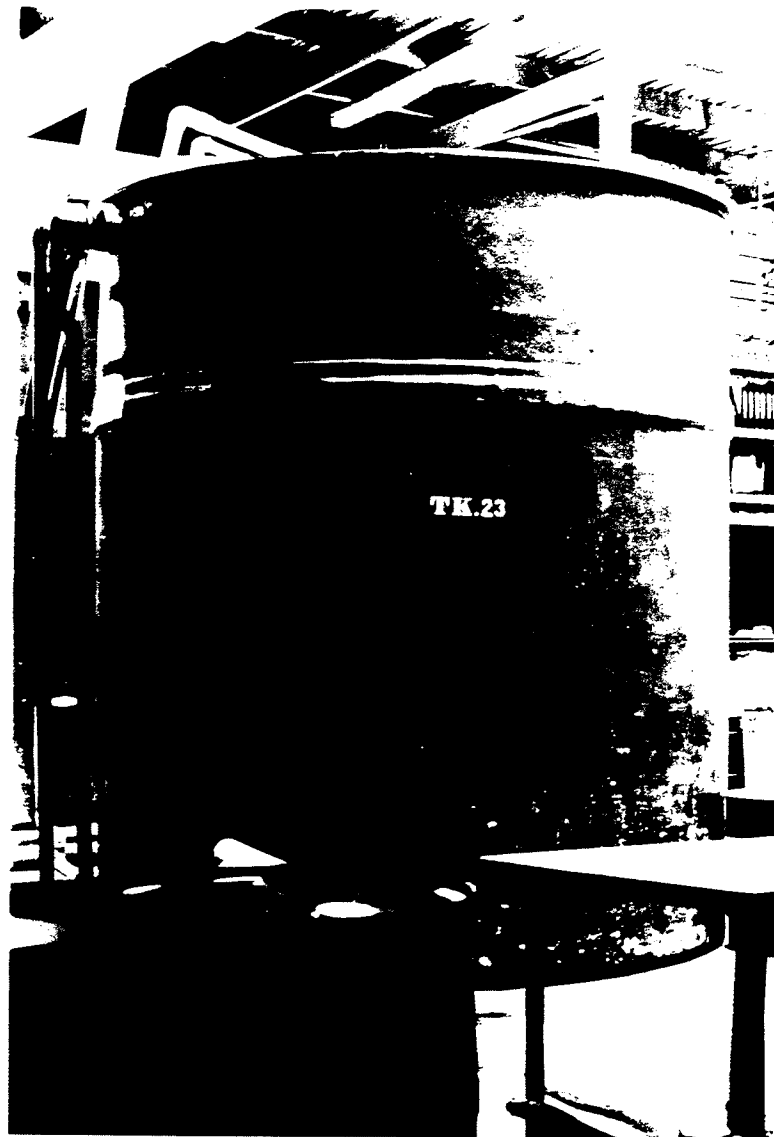
Photo no 31 : Filter Press Feeding Tank, 3,000 gallon,
at the Wastewater Treatment Plant.

Note : TK-23 was formerly used for storage
of F006 sludge prior to out-site disposal.
